INDOOR AIR QUALITY ASSESSMENT

Henry Lord Middle School 151 Amity Street Fall River, MA 02721

Prepared by:
Massachusetts Department of Public Health
Center for Environmental Health
Emergency Response/Indoor Air Quality Program
February 2006

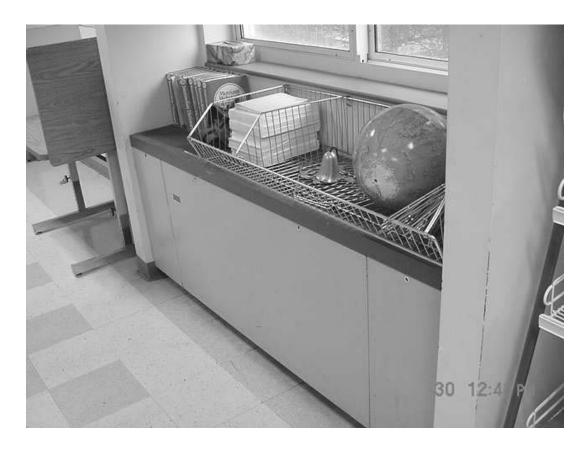
Fresh air in each classroom is supplied by a computer-controlled unit ventilator (univent) system (Picture 1). A univent draws air from outdoors through a fresh air intake located on the exterior wall of the building (Picture 2) and returns air through an air intake located at the base of the unit (Figure 1). Fresh and return air are mixed, filtered, heated or cooled and provided to classrooms through an air diffuser located in the top of the unit. Adjustable louvers control the ratio of fresh outdoor air to recirculated air. Univents have a control switch for settings of off, low or high (Picture 3). Some classrooms have univents installed above the ceiling that are ducted to classrooms via multi-directional air diffusers (Picture 4). Univents that had been deactivated were found in a number of areas (Table 1). Obstructions to airflow, such as items stored on or in front of univents were seen in some areas (Pictures 1 and 5). In order for univents to provide fresh air as designed, units must be activated while rooms are occupied and air diffusers should remain free of obstructions.

Classroom Univent, Note Storage of Materials on Air Diffuser

- 7. Inspect exhaust motors and belts for proper function. Repair and replace as necessary.
- 8. Remove all blockages from univents to ensure adequate airflow.

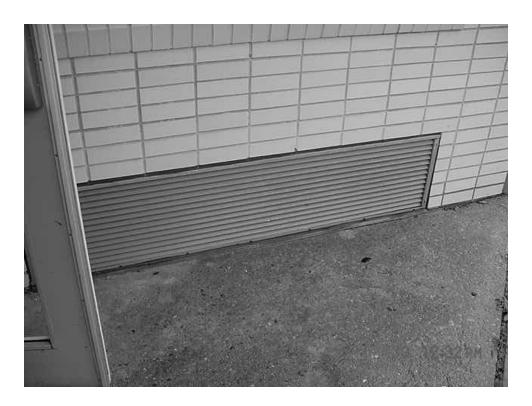
Univent Outside Air Intake

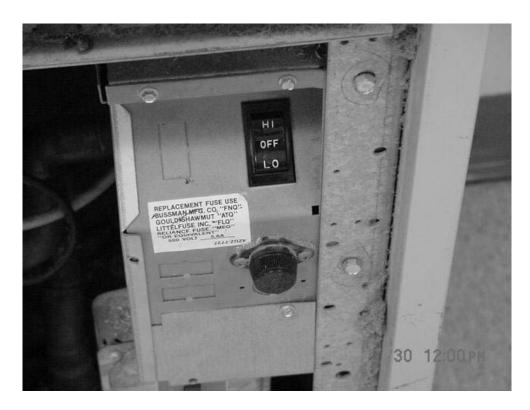
Univent Control Switch Set to the off Position in Classroom

- 6. Operate all ventilation systems throughout the building (e.g., gym, cafeteria, classrooms) continuously during periods of school occupancy and independent of thermostat control. To increase airflow in classrooms, set univent controls to "high".

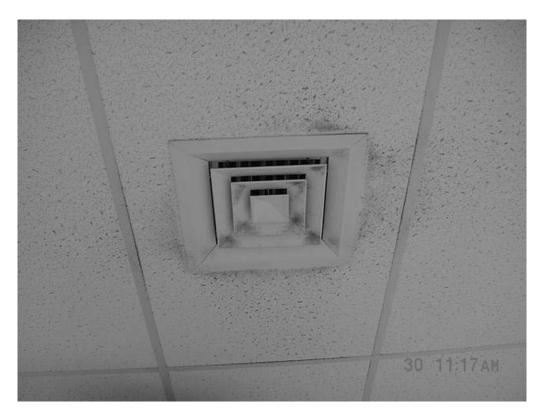
Finally, a number of classroom supply and exhaust vents were noted with accumulated dust (Pictures 4 and 18). If not operating, back drafting may occur, resulting in re-aerosolization of accumulated dust particles. Dust can be irritating to the eyes, nose and respiratory tract. Vents should also be cleaned periodically to prevent dust accumulation on louvers.

Multi-Directional Air Diffuser for Ceiling-Mounted Univent, Note Dust/Dirt Accumulation on Diffuser and on Adjacent Ceiling Tiles

- 15. Store cleaning products properly and out of reach of students.
- 16. Refrain from using strongly scented items, such as plug-in air deodorizers.
- 17. Clean univent air diffusers and exhaust vents periodically of accumulated dust.

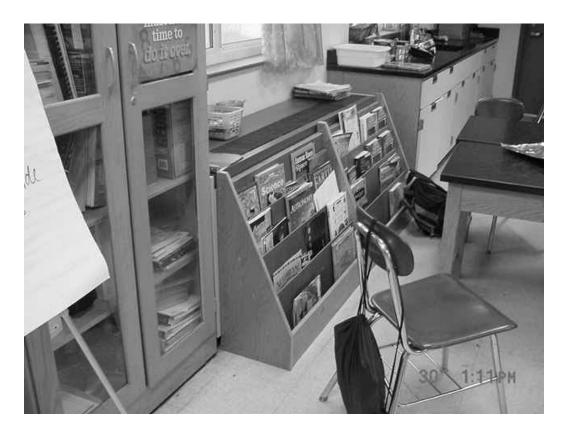
Univent Return Vent (Bottom Front of Unit) Obstructed by Bookcase

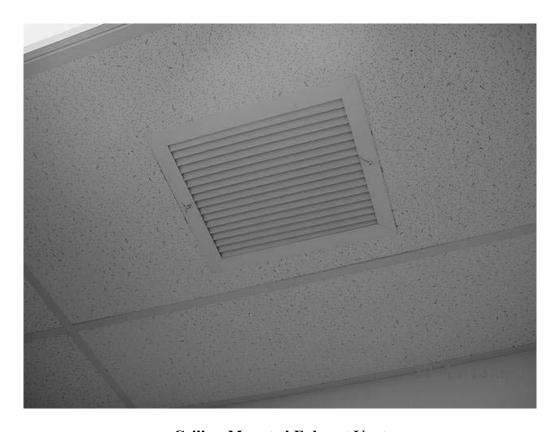
The mechanical exhaust ventilation system consists of ceiling-mounted exhaust vents (Picture 6) ducted to rooftop motors. Exhaust vents were not functioning in the portion of the building that contains rooms 201-205. Without sufficient supply and exhaust ventilation, environmental pollutants can build up and lead to indoor air quality/comfort complaints.

Ceiling-Mounted Exhaust Vent

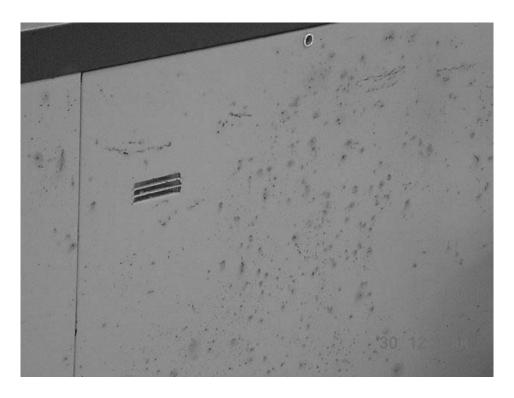
occurred around univent air intakes during heavy rains. These areas were reportedly sealed. No visible mold was observed during the MDPH assessment; however, historic water damage in this area is evidenced by rusted metal on ceiling tracks, univent covers and file cabinets and peeling paint (Pictures 7-10). A black gum-like substance observed on and around seams of floor tiles, which appears to be mastic from beneath the tiles, is also evidence of water damage (Pictures 11 and 12).

Rust Spots on Front Cover of Univent Cabinet Indicating Chronic Exposure to Moisture, Classroom 143

- 1. Continue to monitor breaches in the building envelope (e.g., around univent air intakes) to ensure they are sealed to prevent further water penetration.
- Ensure windows closed during hot, humid weather to maintain indoor temperatures and to avoid condensation problems.
- 3. Consider removing several tiles in areas of chronic water damage (classrooms 143 and 145) to determine if visible moisture and/or microbial growth are present. If so, the removal of all affected tiles followed by cleaning with an appropriate antimicrobial agent may be necessary.

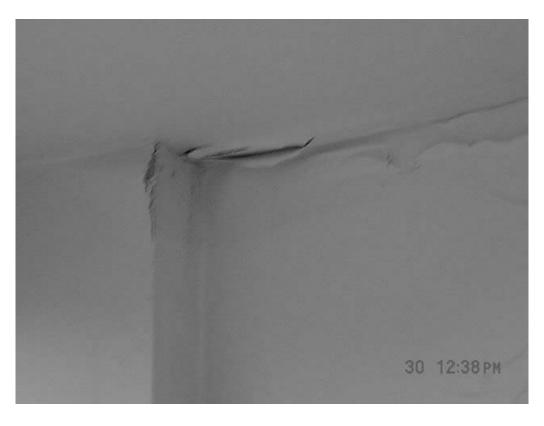
Peeling Paint in Classroom 143

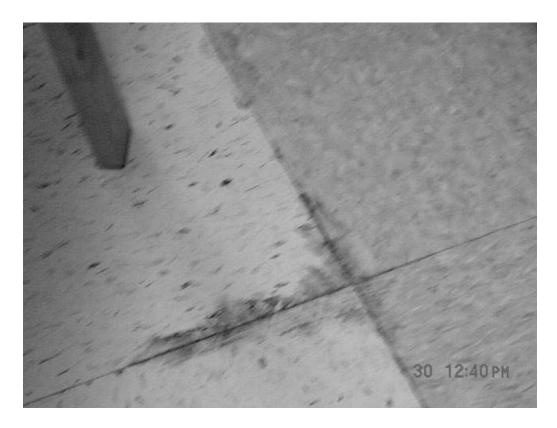
Although water infiltration may be a possible source of moisture impacting floor tiles, high indoor relative humidity during summer months also appears to be a likely source of moisture in the building. Potential sources for the introduction of humid outside air include opening windows and exterior doors while univents are operating in the air-conditioning setting. Introduction of uncontrolled hot, moist air in an air-conditioned building likely generates condensation on chilled surfaces. Over time, water droplets can form. The accumulation of condensation on a chilled surface would, in turn, moisten building materials. Condensation is the collection of moisture on a surface at or below the dew point. The dew point is the temperature that air must reach for saturation to occur. The dew point is a temperature determined by air temperature and relative humidity.

Gum-Like/Mastic Material on/around Floor Tiles, Classroom 143

- Consider contacting a reputable flooring contractor to remove/replace old tiles and mastic. Slab should be completely cleaned and sealed with a proper sealant and/or vapor barrier.

- 5. Consider contacting a building engineer for an examination of possible moisture remediation/prevention strategies if moisture accumulation/damage to floor tiles in the building recurs.

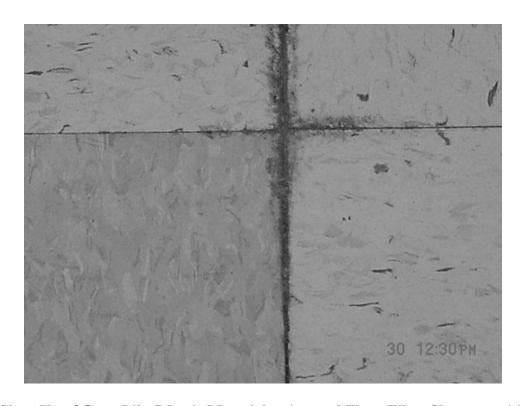
Close-Up of Gum-Like/Mastic Material on/around Floor Tiles, Classroom 143

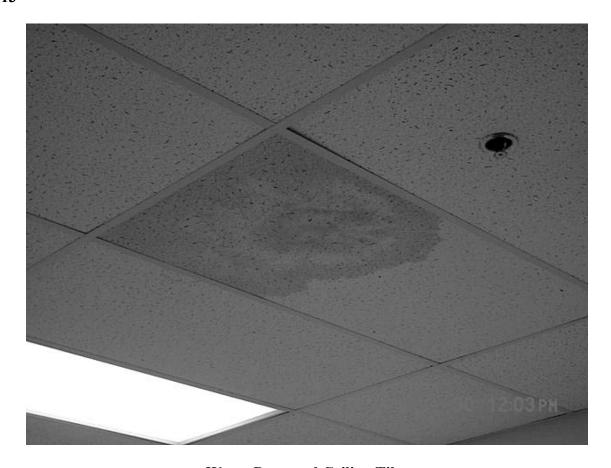
Several areas had water damaged ceiling tiles (Picture 13); a water stained lighting panel was observed in room 250-B (Picture 14). Such damage can indicate leaks from the roof or plumbing system. During the assessment, an active leak was observed in the boy's locker room (Picture 15). Water-damaged ceiling tiles and other porous building materials can provide a source of mold and should be replaced after a moisture source or leak is discovered and repaired.

Water Damaged Ceiling Tiles

- 13. Replace water-damaged ceiling tiles. Examine the area above and around these areas for mold growth. Disinfect areas of water leaks with an appropriate antimicrobial.

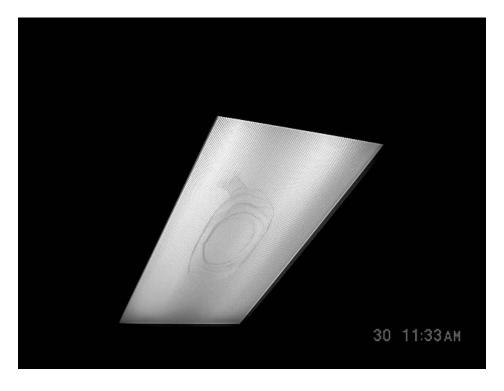
Water Damaged Lighting Panel in Room 250-B

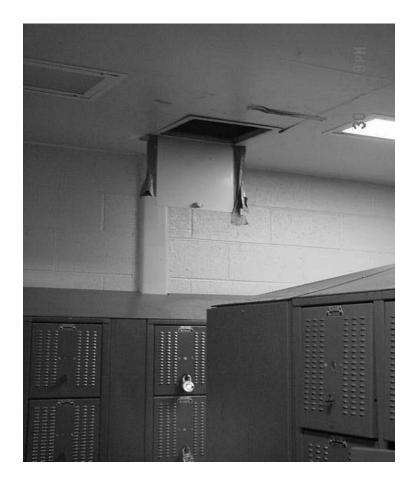
Active Ceiling Leak in Boy's Locker Room

- ease some symptoms associated with a dry environment (e.g., throat and sinus irritations).
- 12. Continue with plans to repair roof leak in boy's locker room.

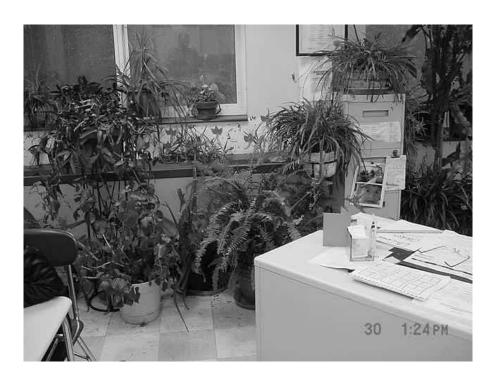
Plants were noted in several classrooms and in close proximity to univent air intakes and diffusers (Picture 16). Plants can be a source of pollen and mold, which can be respiratory irritants for some individuals. Plants should be properly maintained and equipped with drip pans. Plants should also be located away from ventilation sources to prevent the entrainment and/or aerosolization of dirt, pollen or mold.

Plants on and around Classroom Univent

- 14. Move plants away from univents in classrooms. Ensure all plants are equipped with drip pans. Examine drip pans for mold growth and disinfect areas of water leaks with an appropriate antimicrobial where necessary.

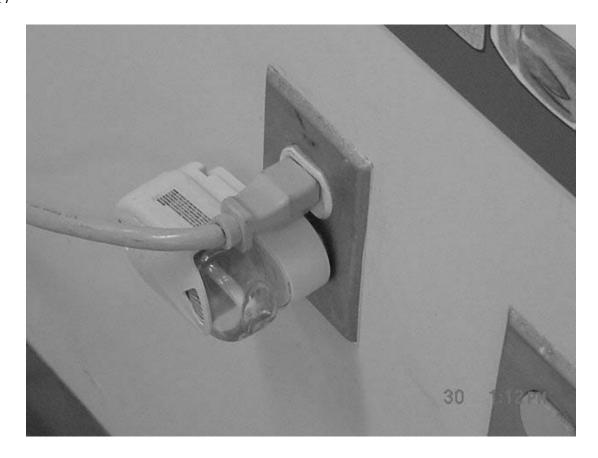
Plug-in air fresheners/deodorizers were in use in some classrooms (Picture 17). These products contain chemicals that can be irritating to the eyes, nose and throat of

sensitive individuals. Furthermore, air fresheners do not remove materials causing odors, but rather mask odors that may be present in the area.

Plug-In Air Freshener in Classroom

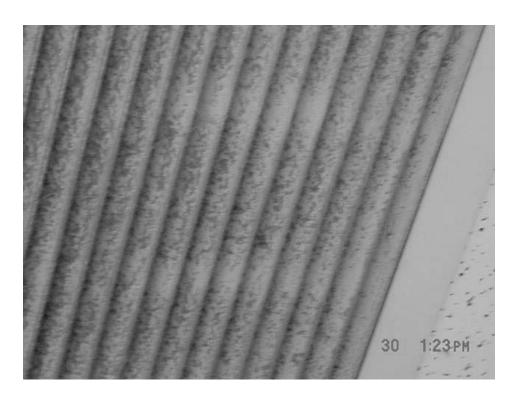
Close-Up of Accumulated Dust on Exhaust Vent
